NRL/FR/6180--97-9861

Virtual Environment Firefighting/Ship Familiarization Feasibility Tests

VIRTUAL ENVIRONMENT FIREFIGHTING/SHIP FAMILIARIZATION FEASIBILITY TESTS

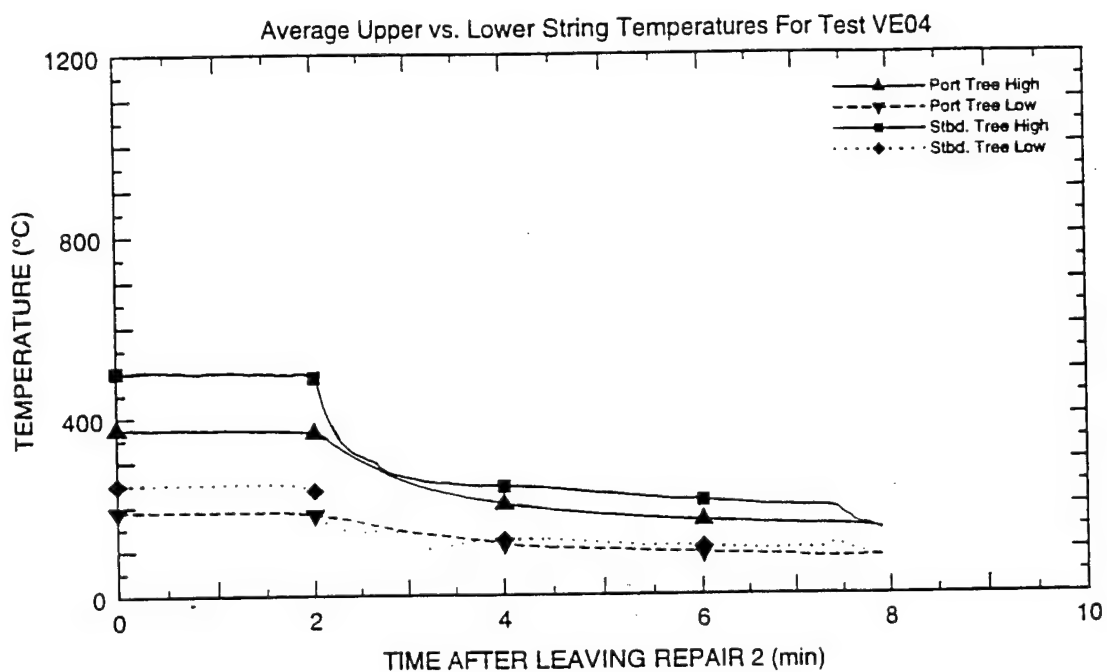
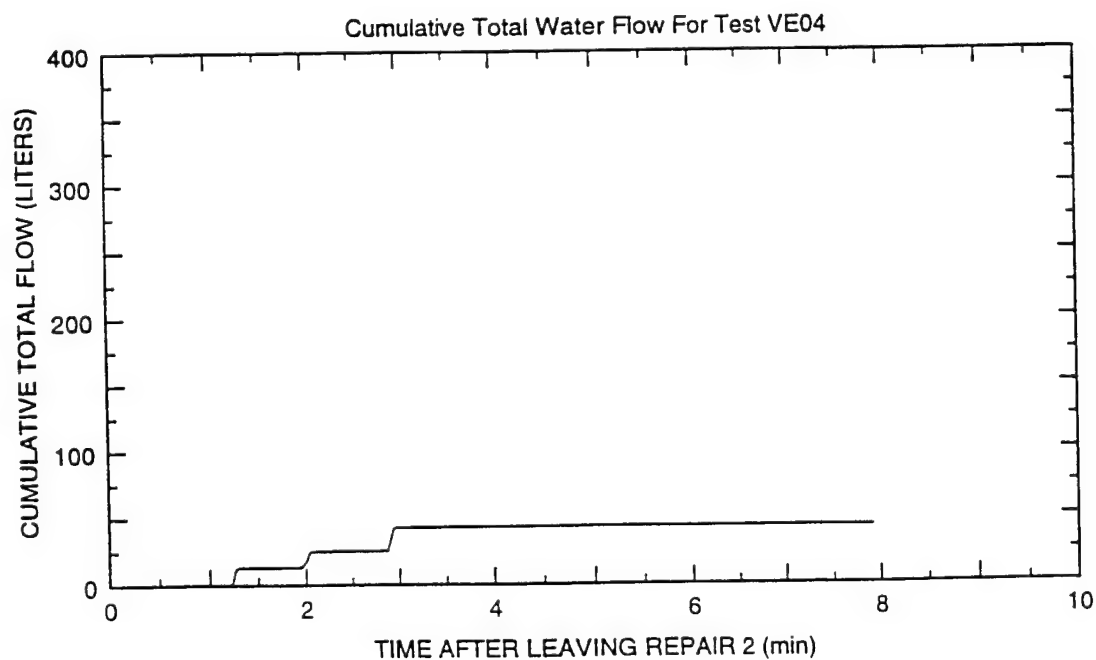
Fig. A8 — Average string temperatures and cumulative total water flow for test VE04

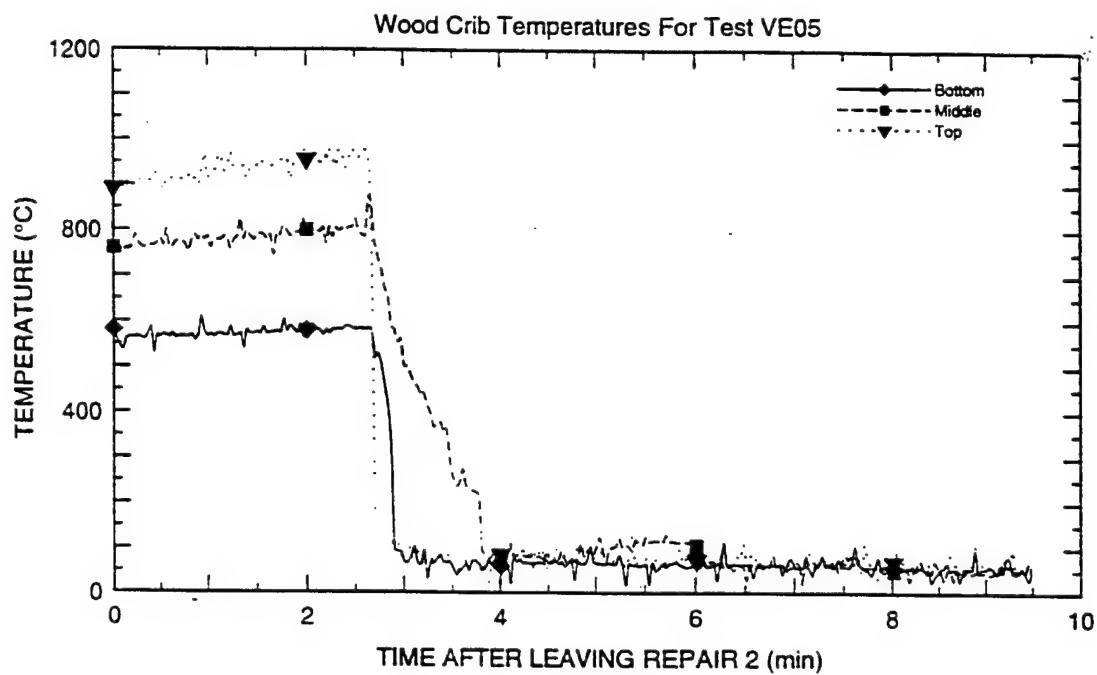
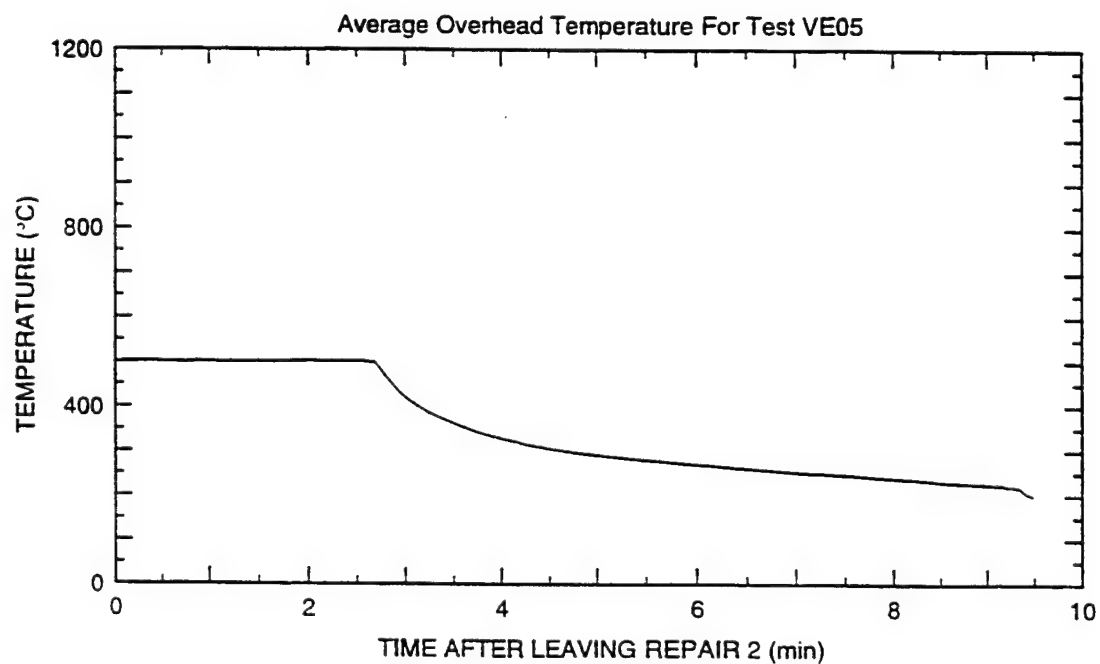
Fig. A9 — Wood crib and average overhead temperatures for test VE05

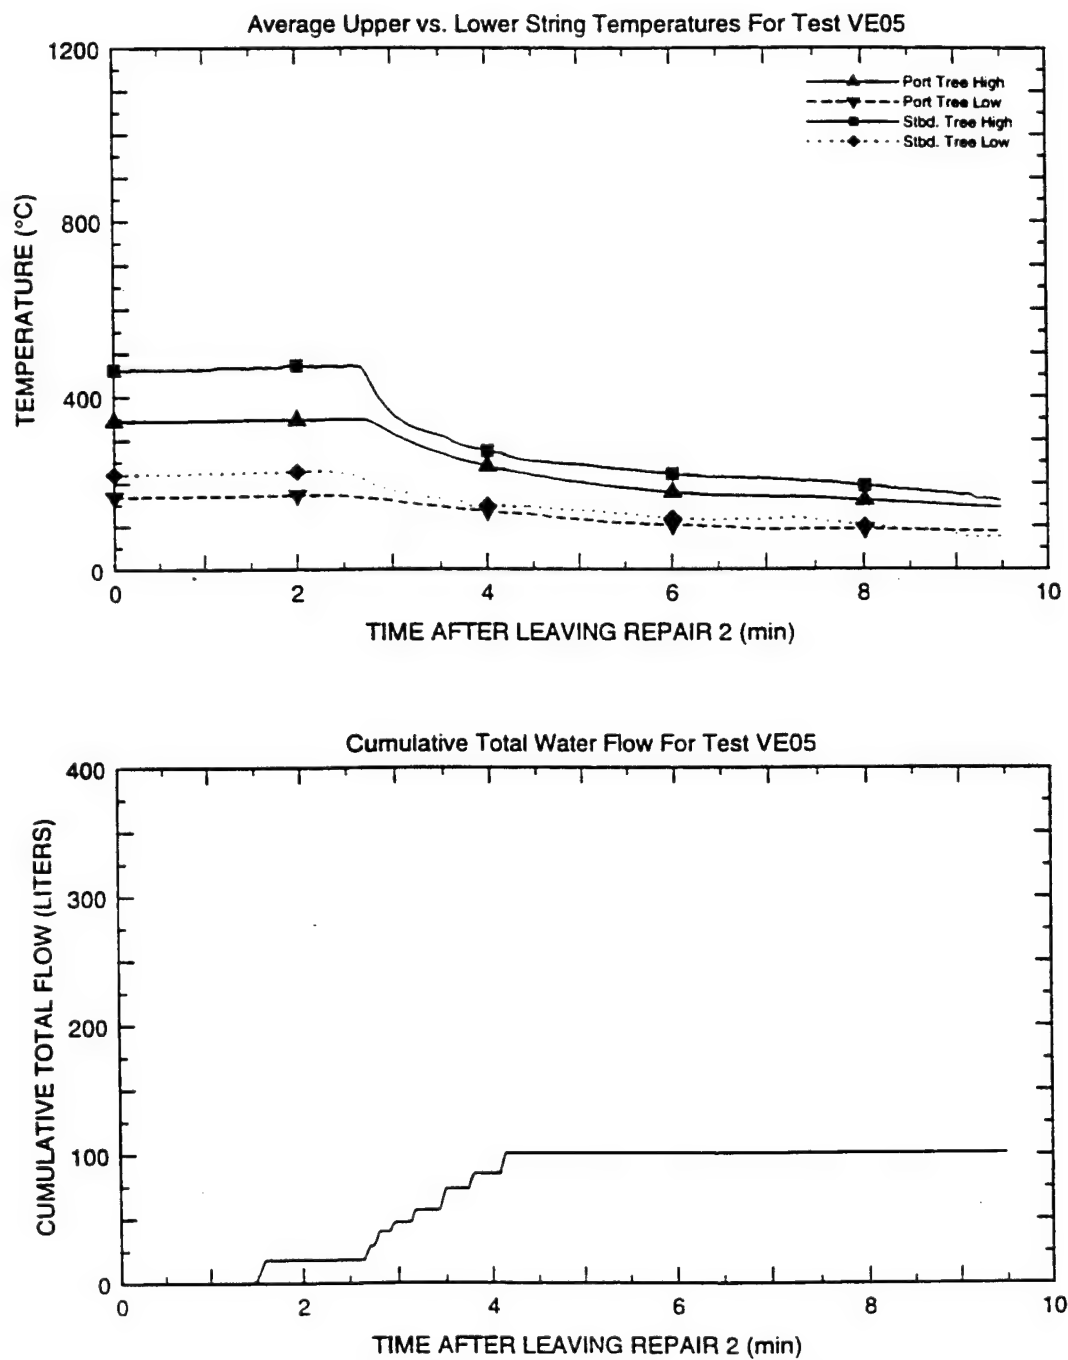
Fig. A10 — Average string temperatures and cumulative total water flow for test VE05

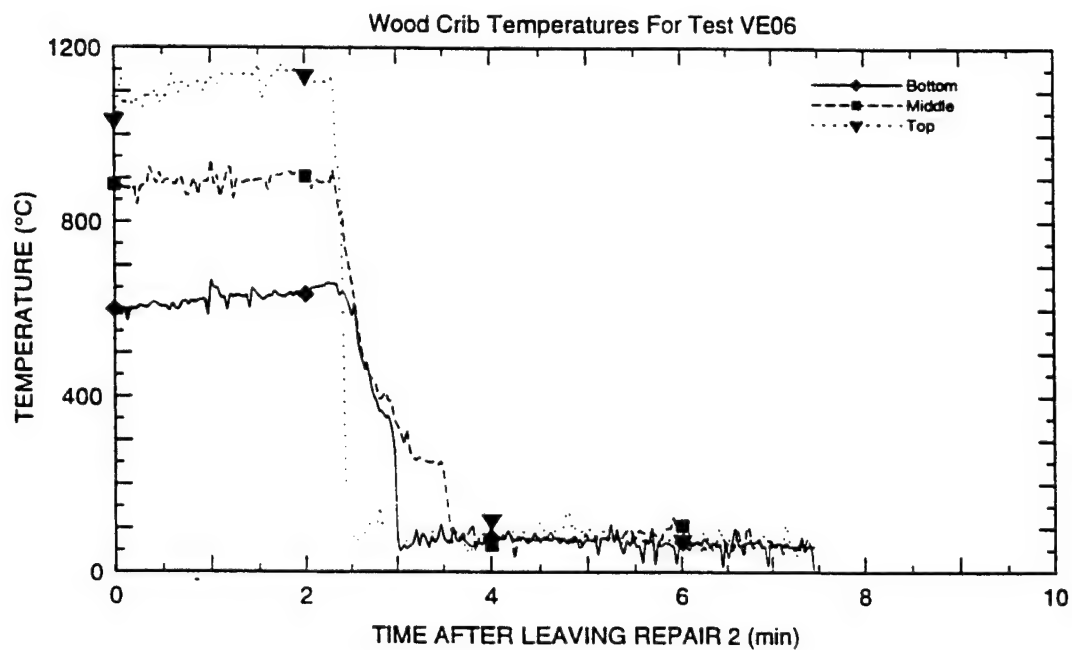
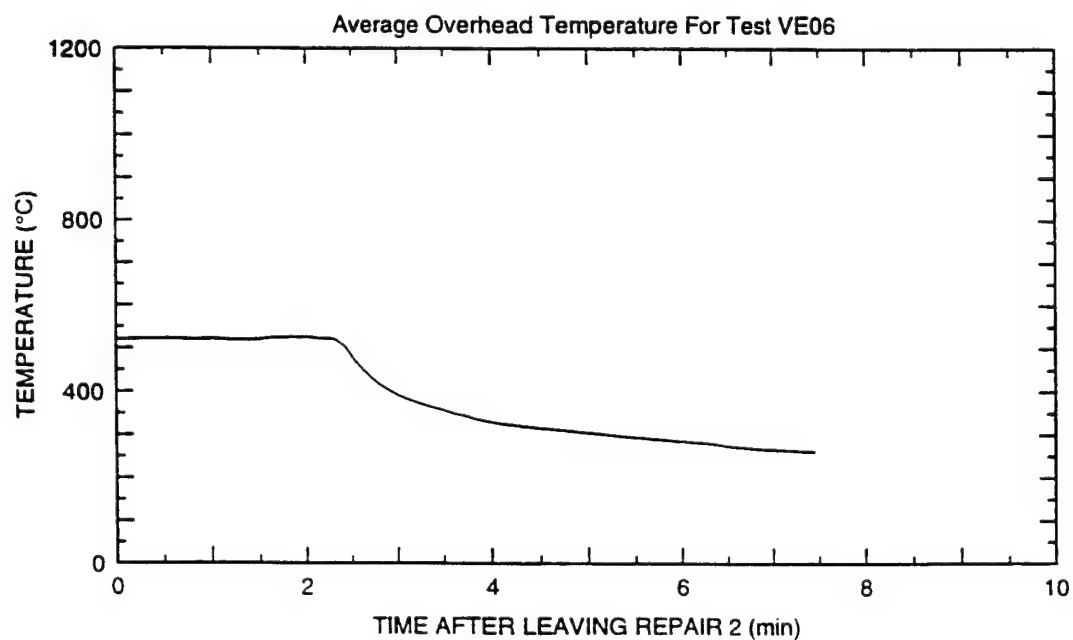
Fig. A11 — Wood crib and average overhead temperatures for test VE06

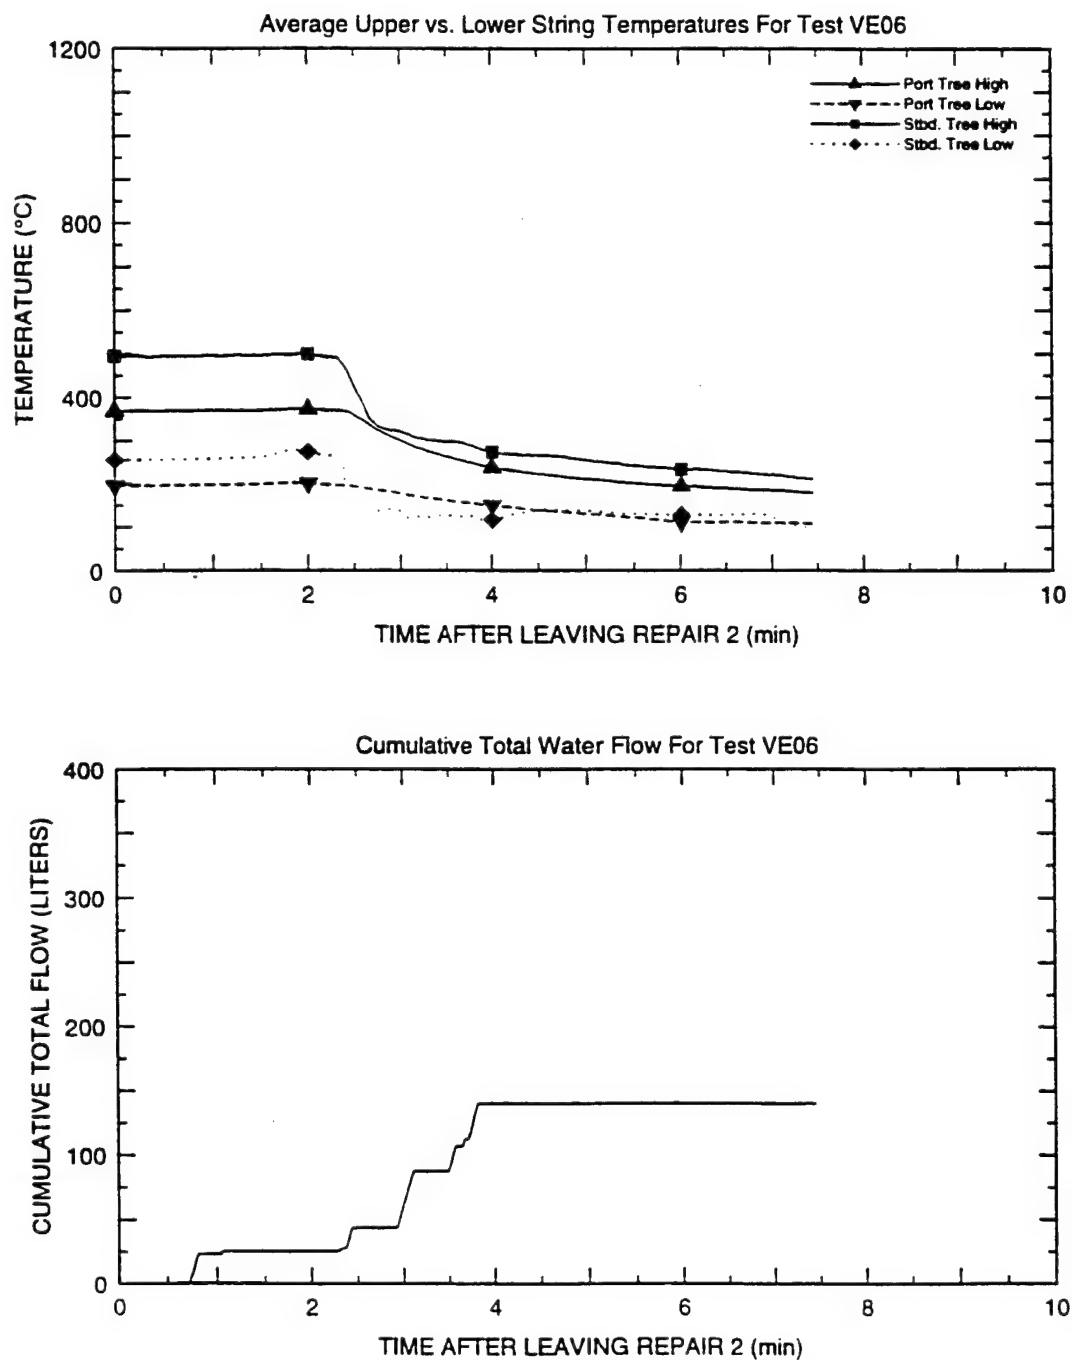
Fig. A12 — Average string temperatures and cumulative total water flow for test VE06

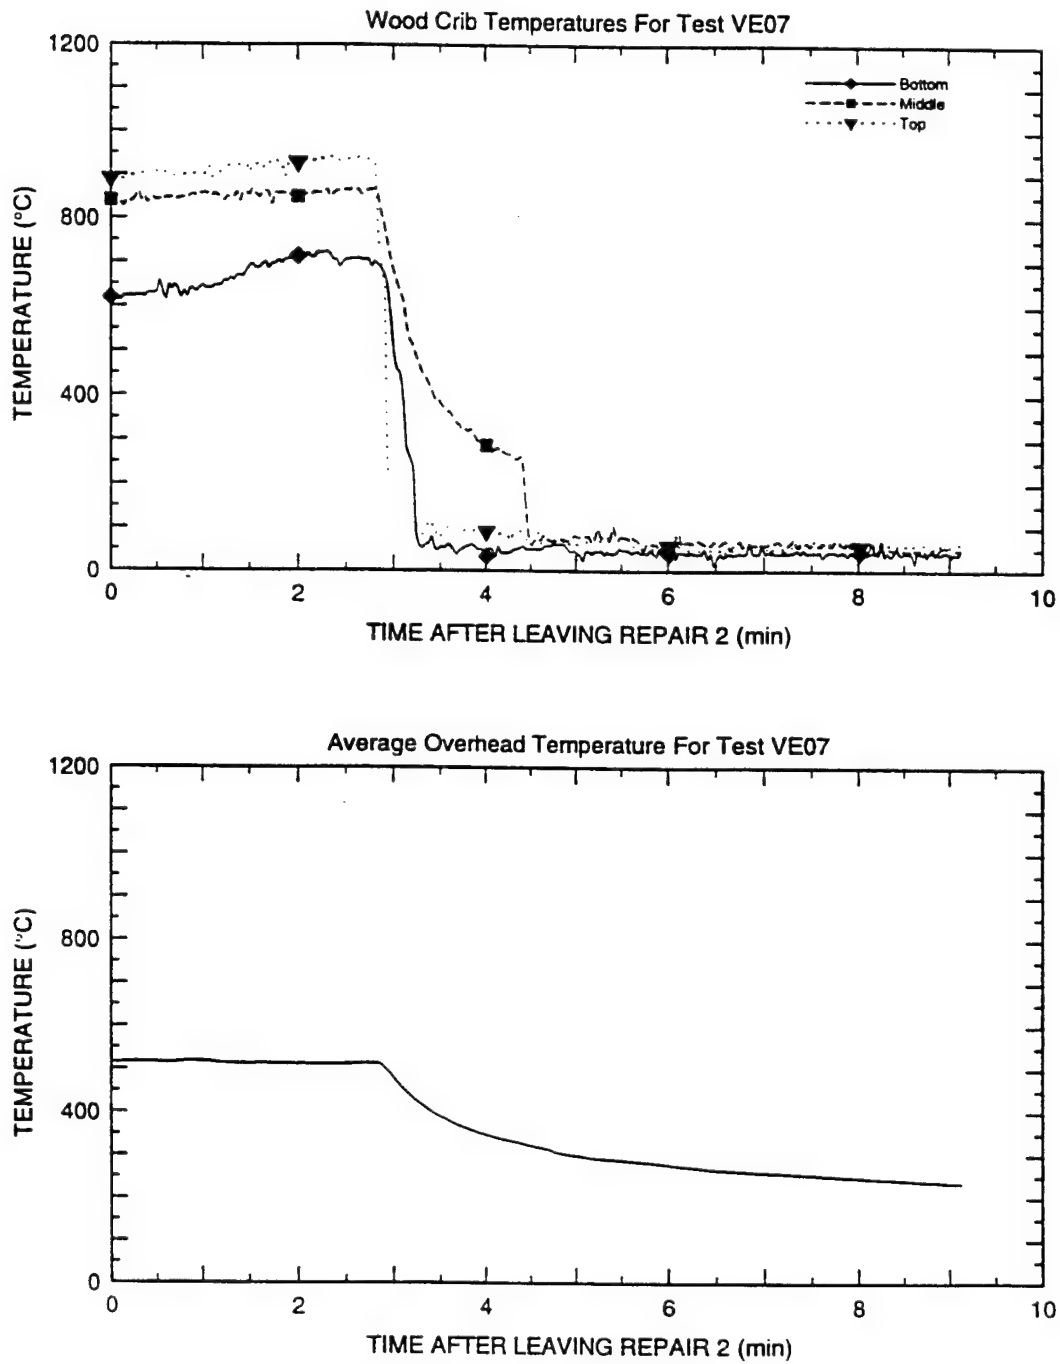
Fig. A13 — Wood crib and average overhead temperatures for test VE07

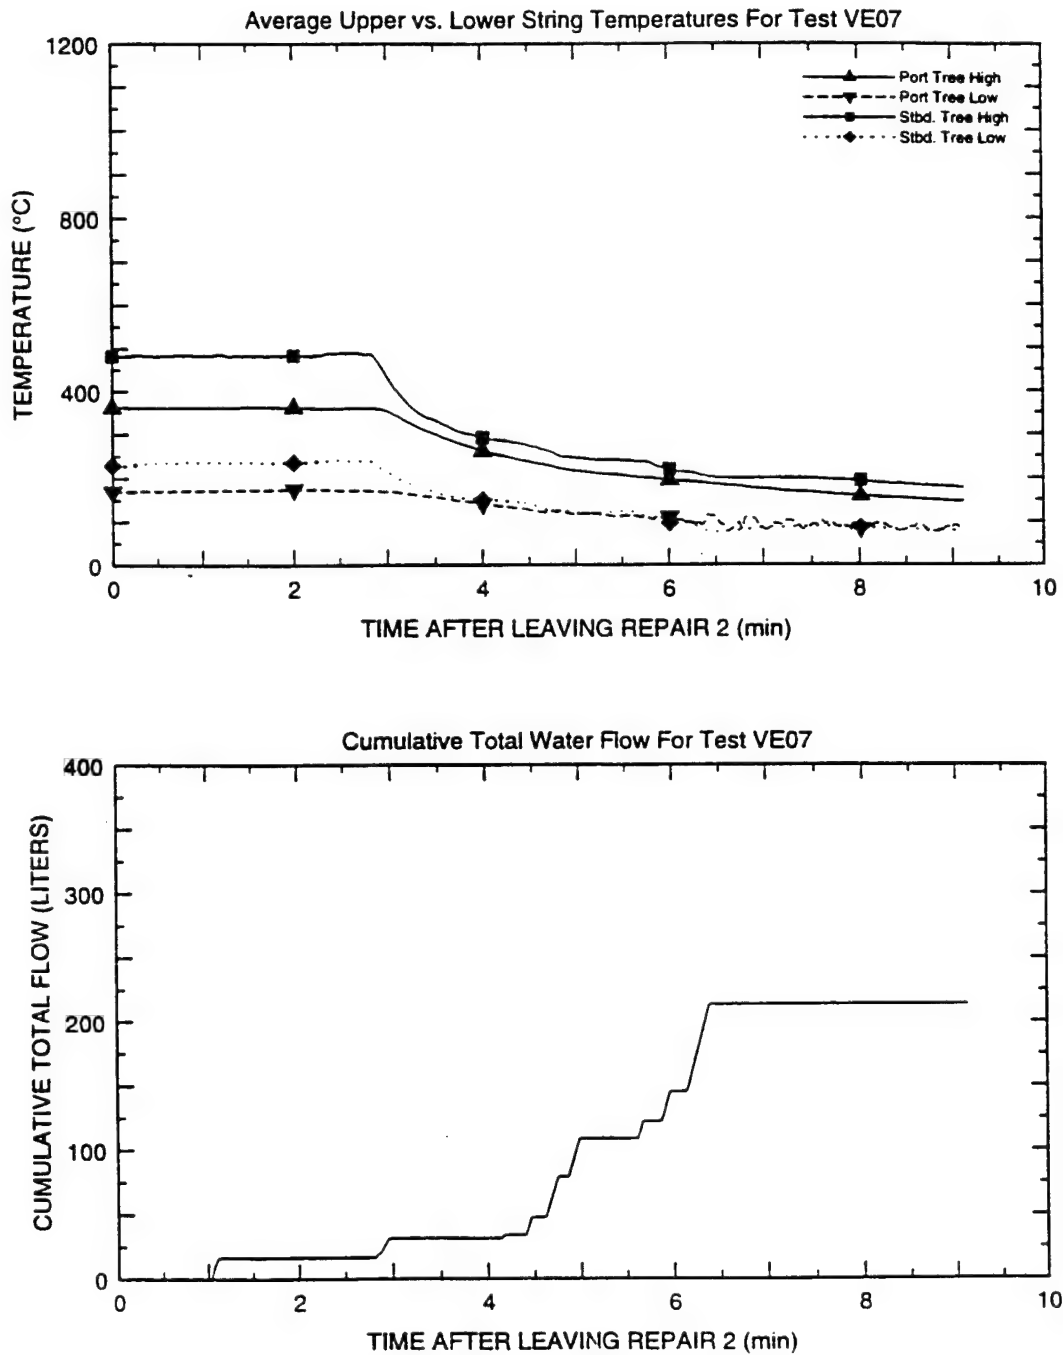
Fig. A14 — Average string temperatures and cumulative total water flow for test VE07

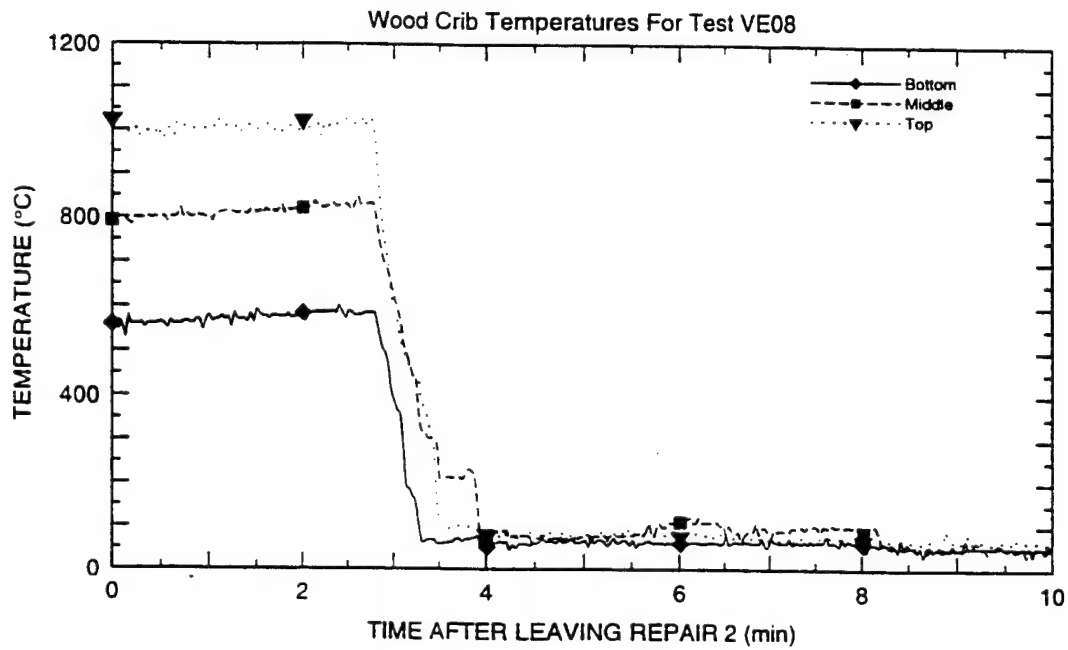
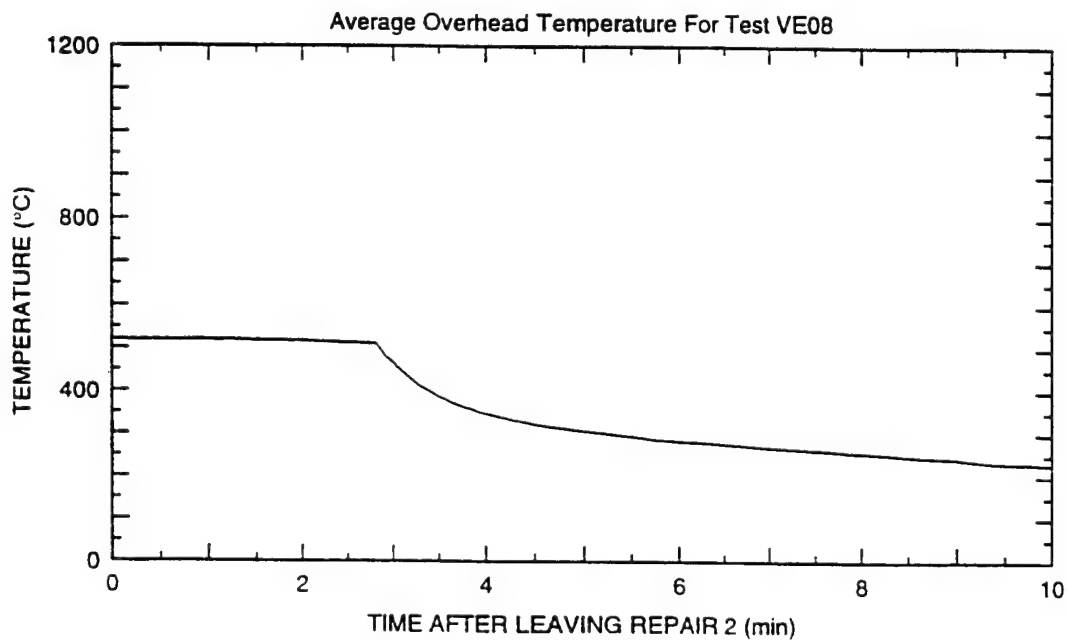
Fig. A15 — Wood crib and average overhead temperatures for test VE08

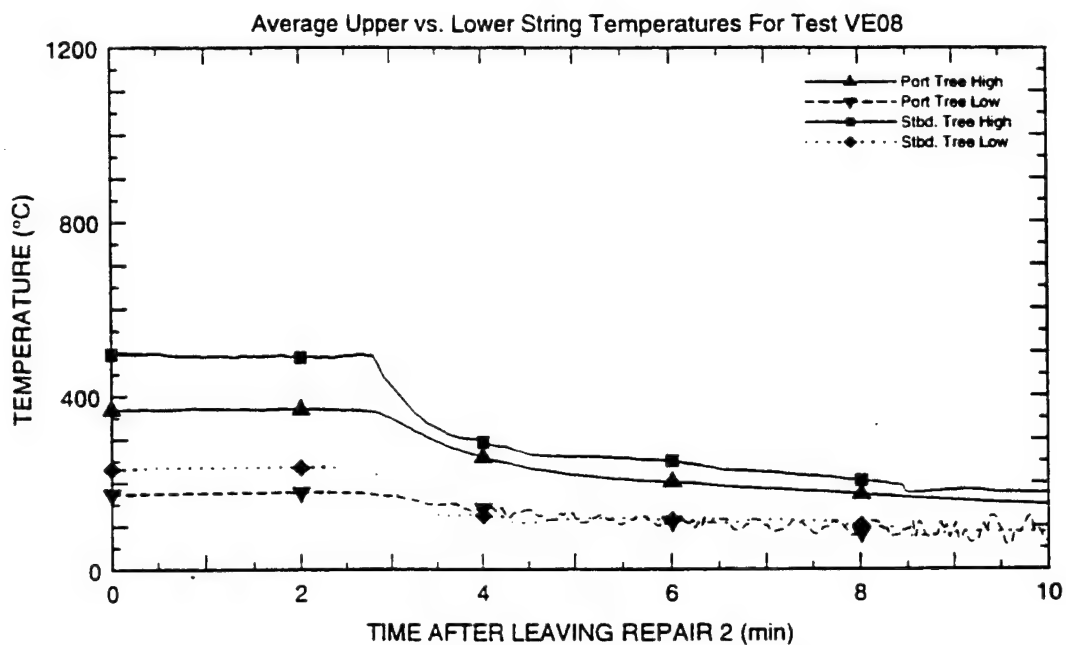
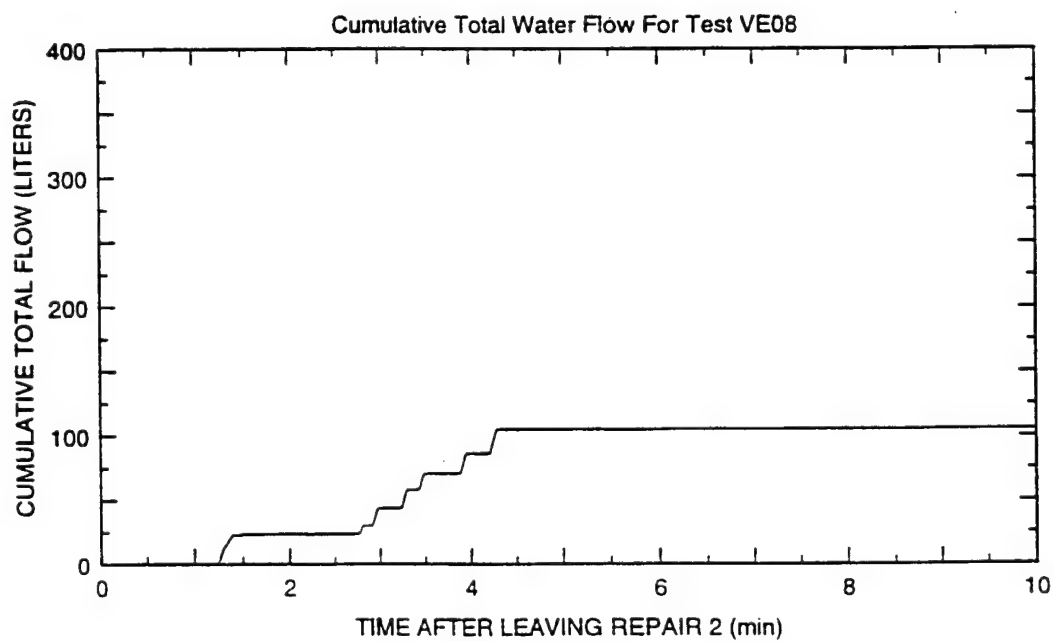
Fig. A16 — Average string temperatures and cumulative total water flow for test VE08

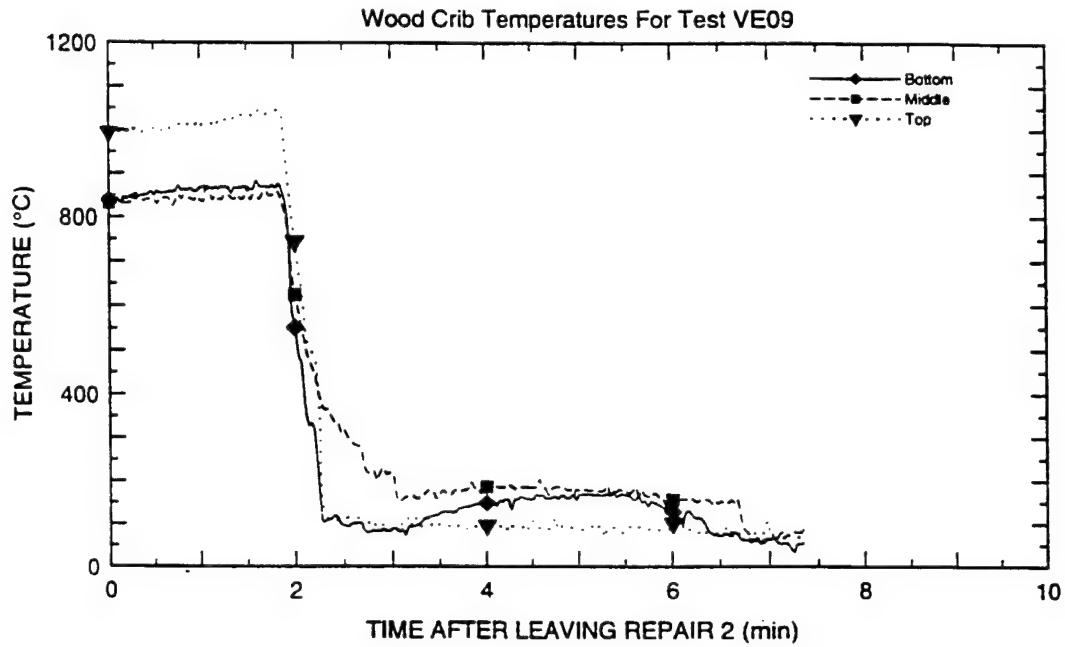
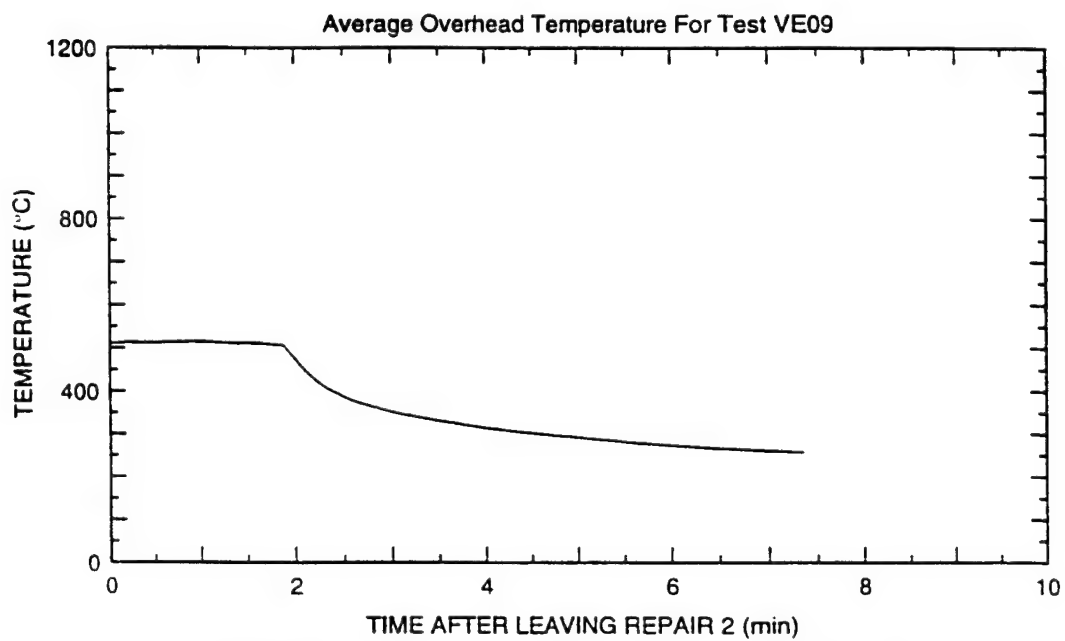
Fig. A17 — Wood crib and average overhead temperatures for test VE09

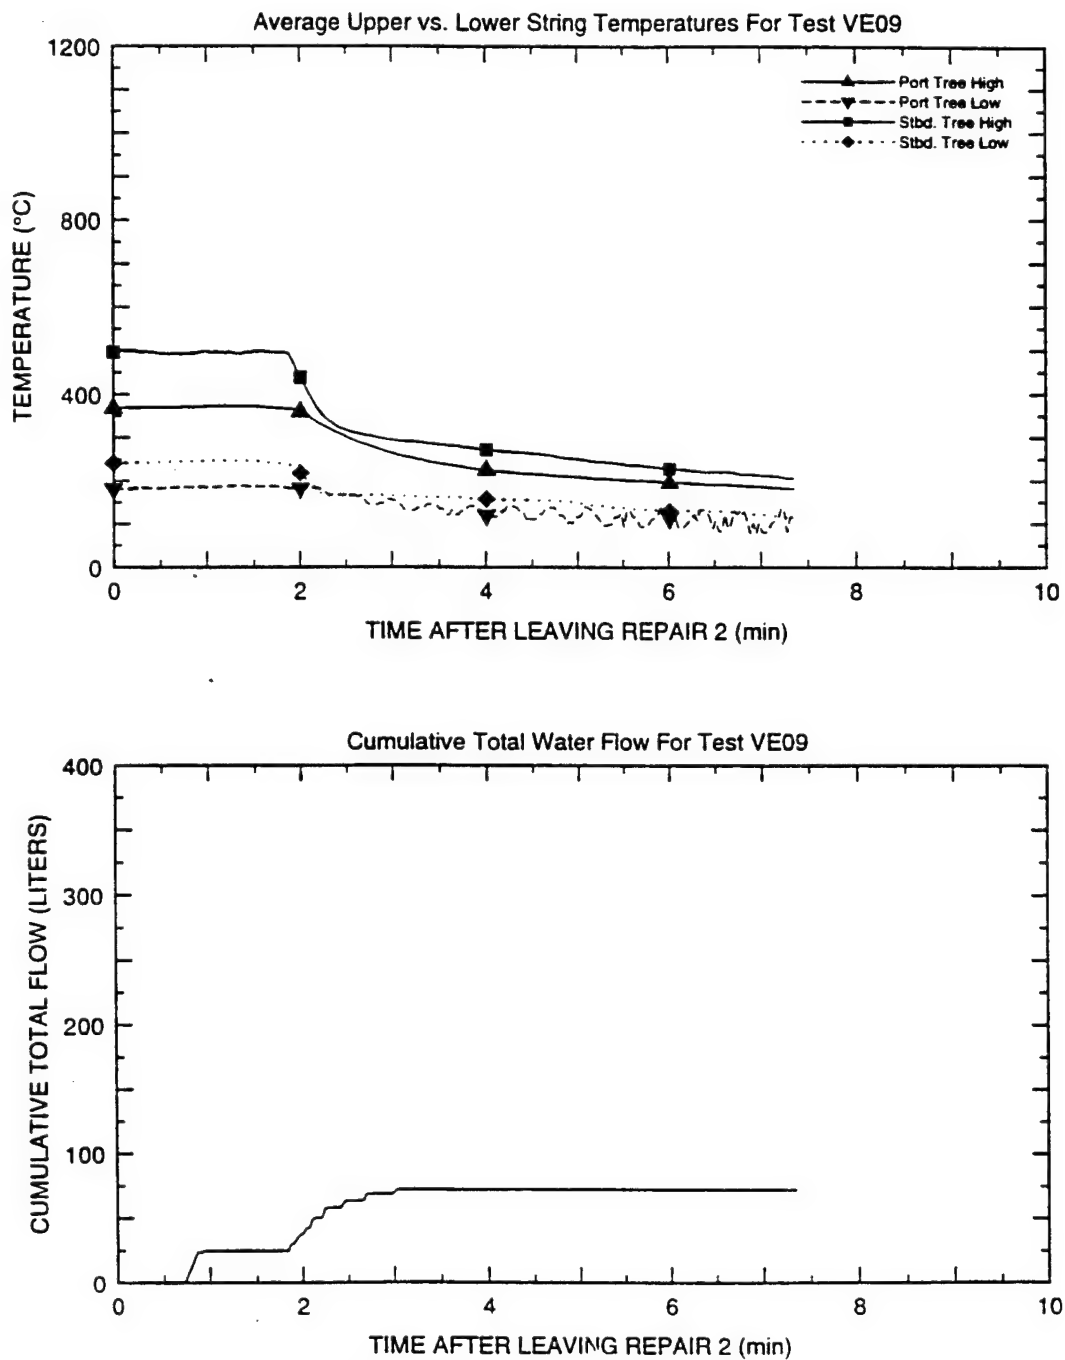
Fig. A18 — Average string temperatures and cumulative total water flow for test VE09

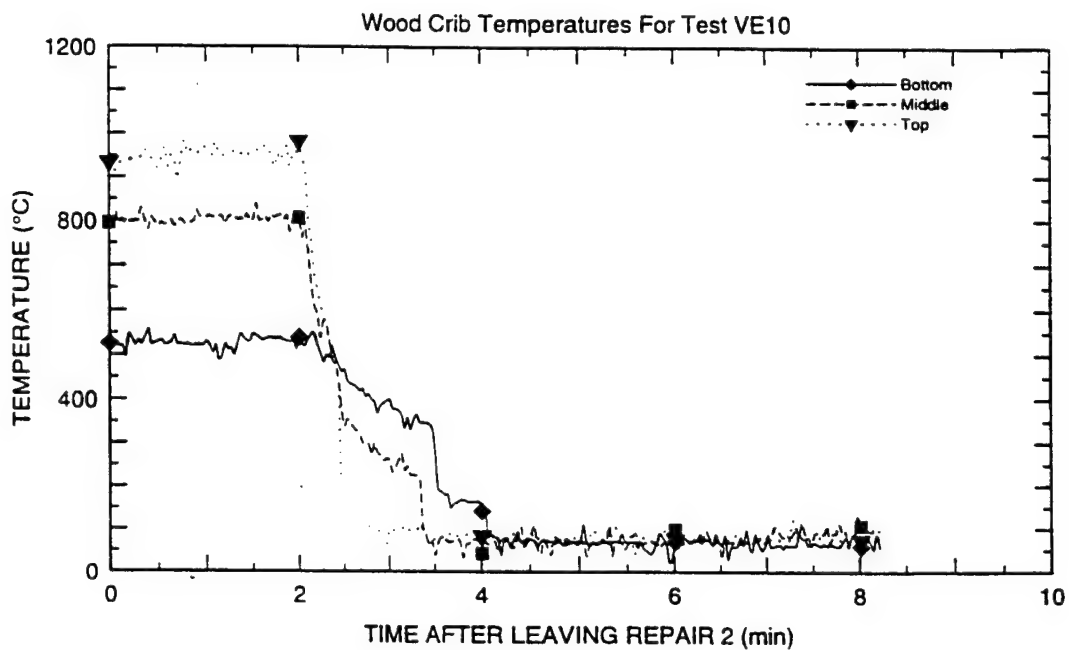
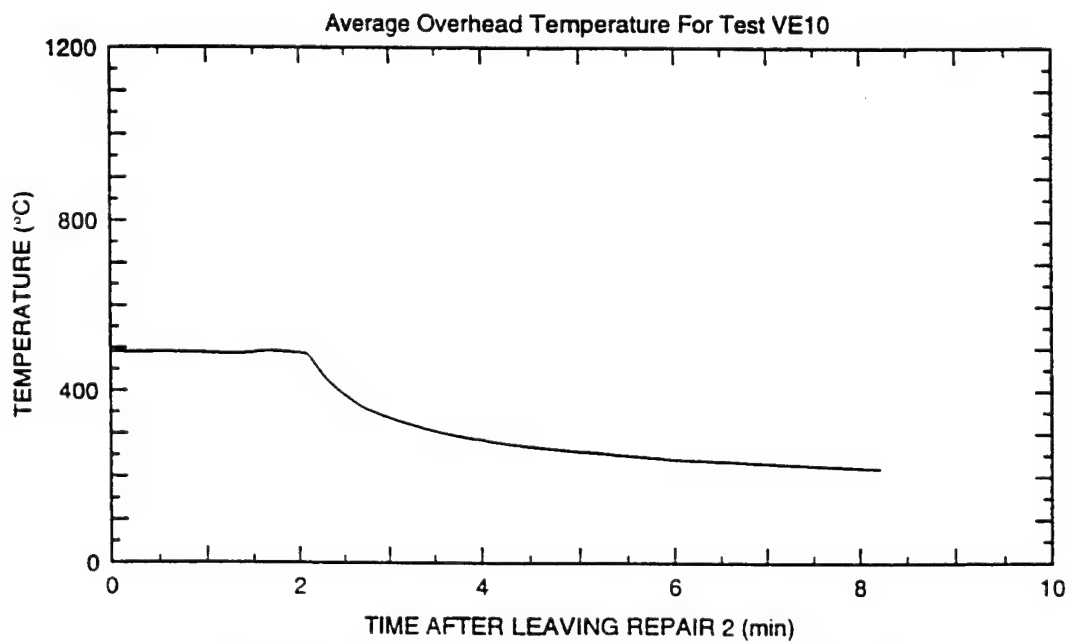
Fig. A19 — Wood crib and average overhead temperatures for test VE010

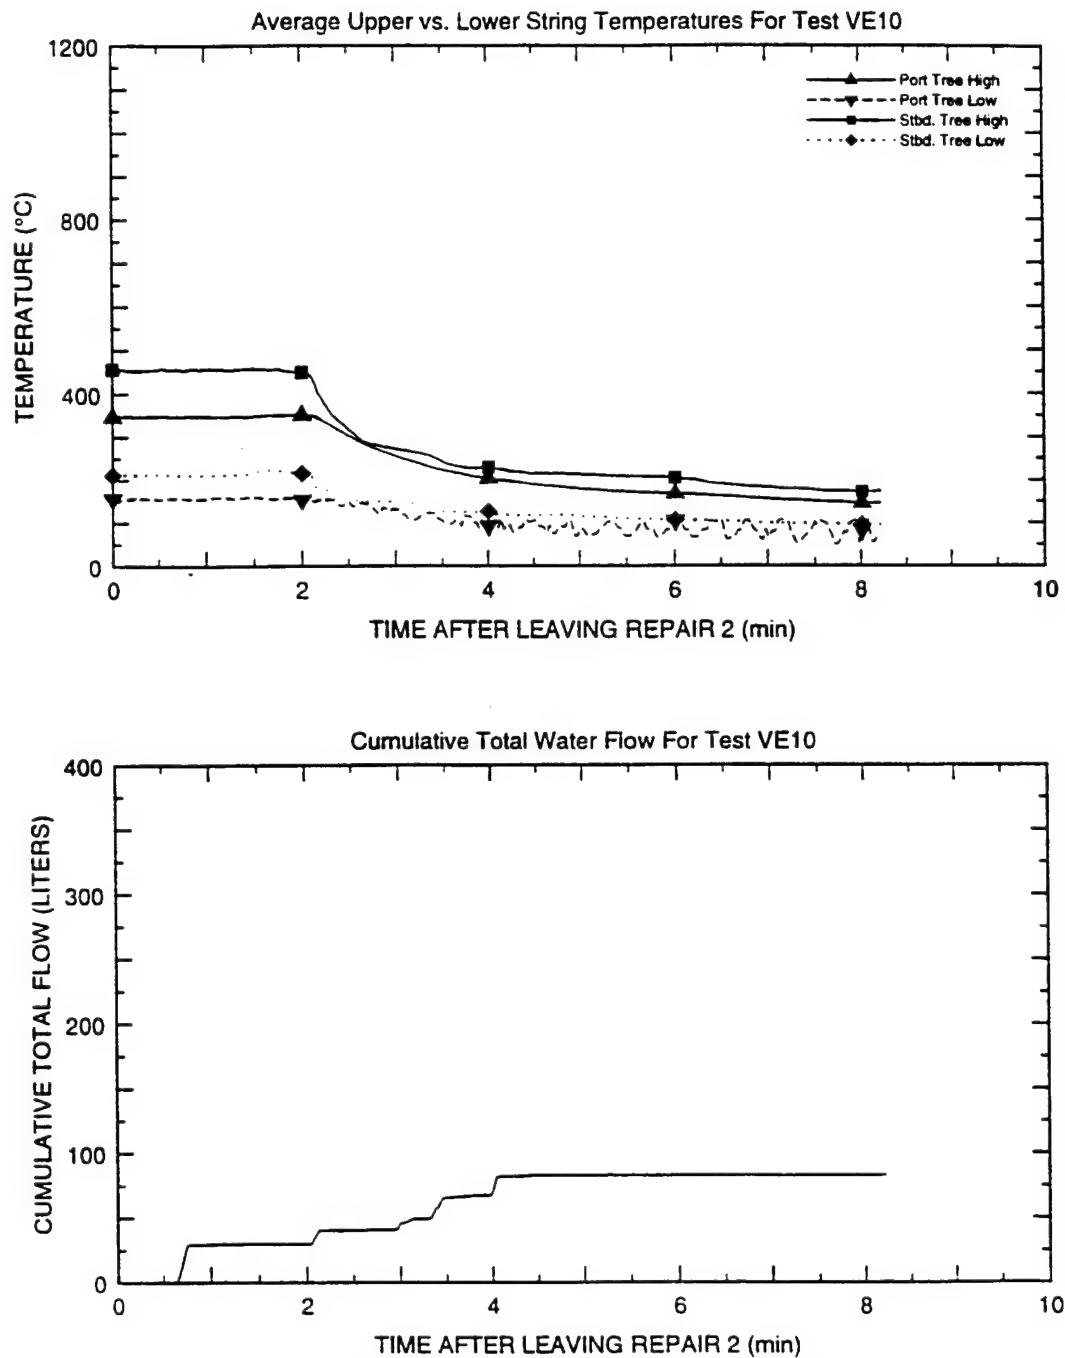
Fig. A20 — Average string temperatures and cumulative total water flow for test VE010

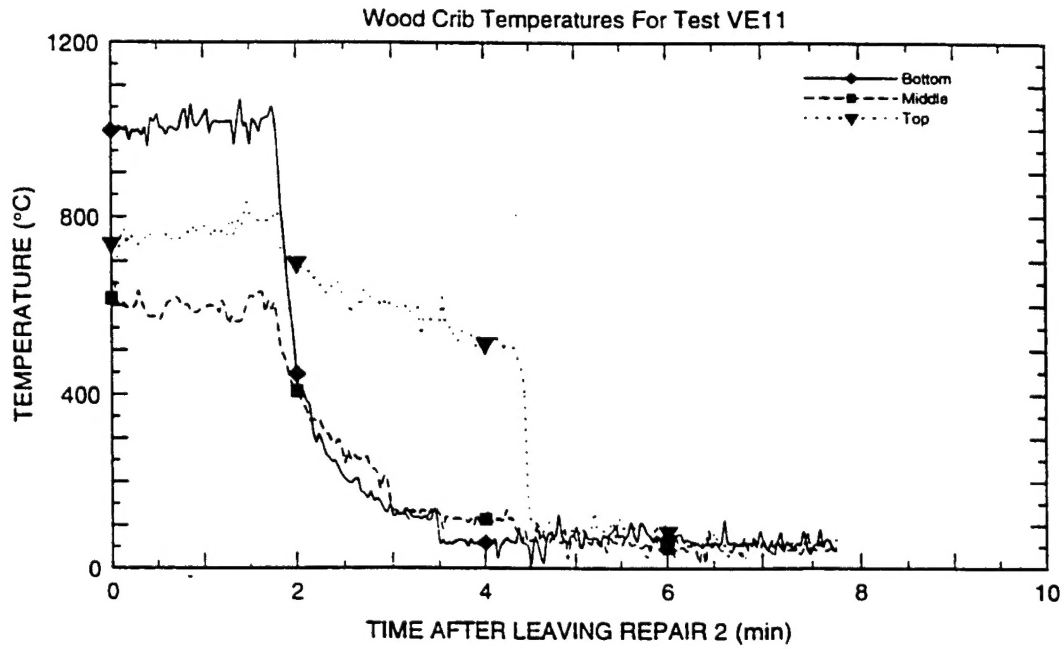
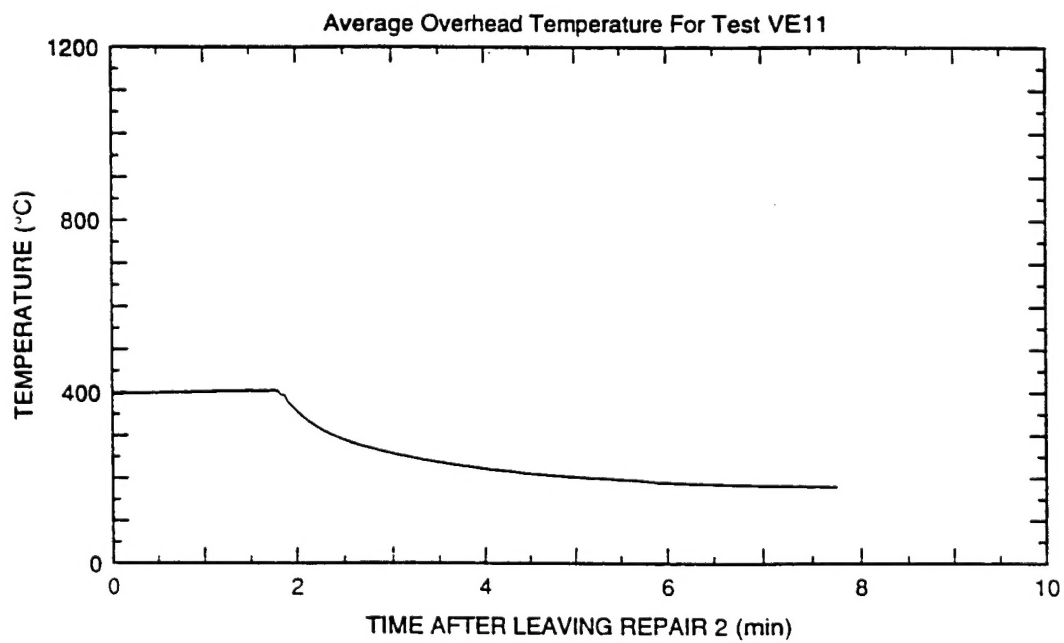
Fig. A21 — Wood crib and average overhead temperatures for test VE011

The data for test VE11 show that temperatures were generally about 100°-200° C (180°-360° F) lower than for the other tests. For this test, 80% of the wood used to construct the crib was previously burned wet wood. Reduced temperatures should be expected in this situation because a greater portion of the energy produced by the combustion process is being used to convert the moisture in the wood into a vapor. Also, because the wood was previously burned, the surface area available for combustion was reduced, which, in turn, results in a lower heat release rate.

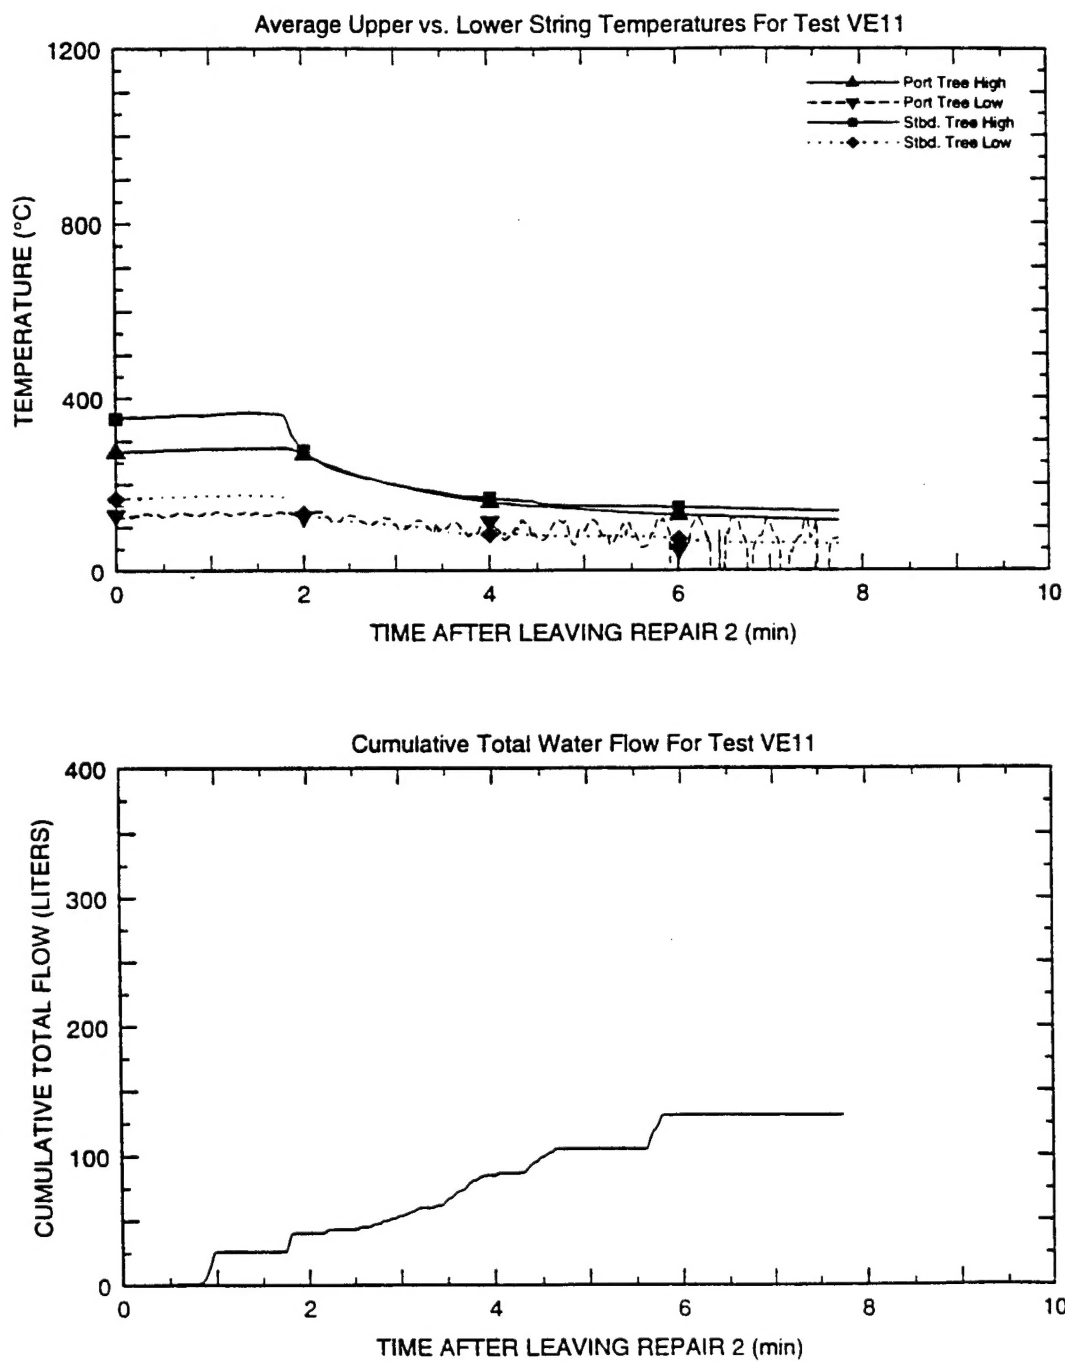
Fig. A22 — Average string temperatures and cumulative total water flow for test VE011

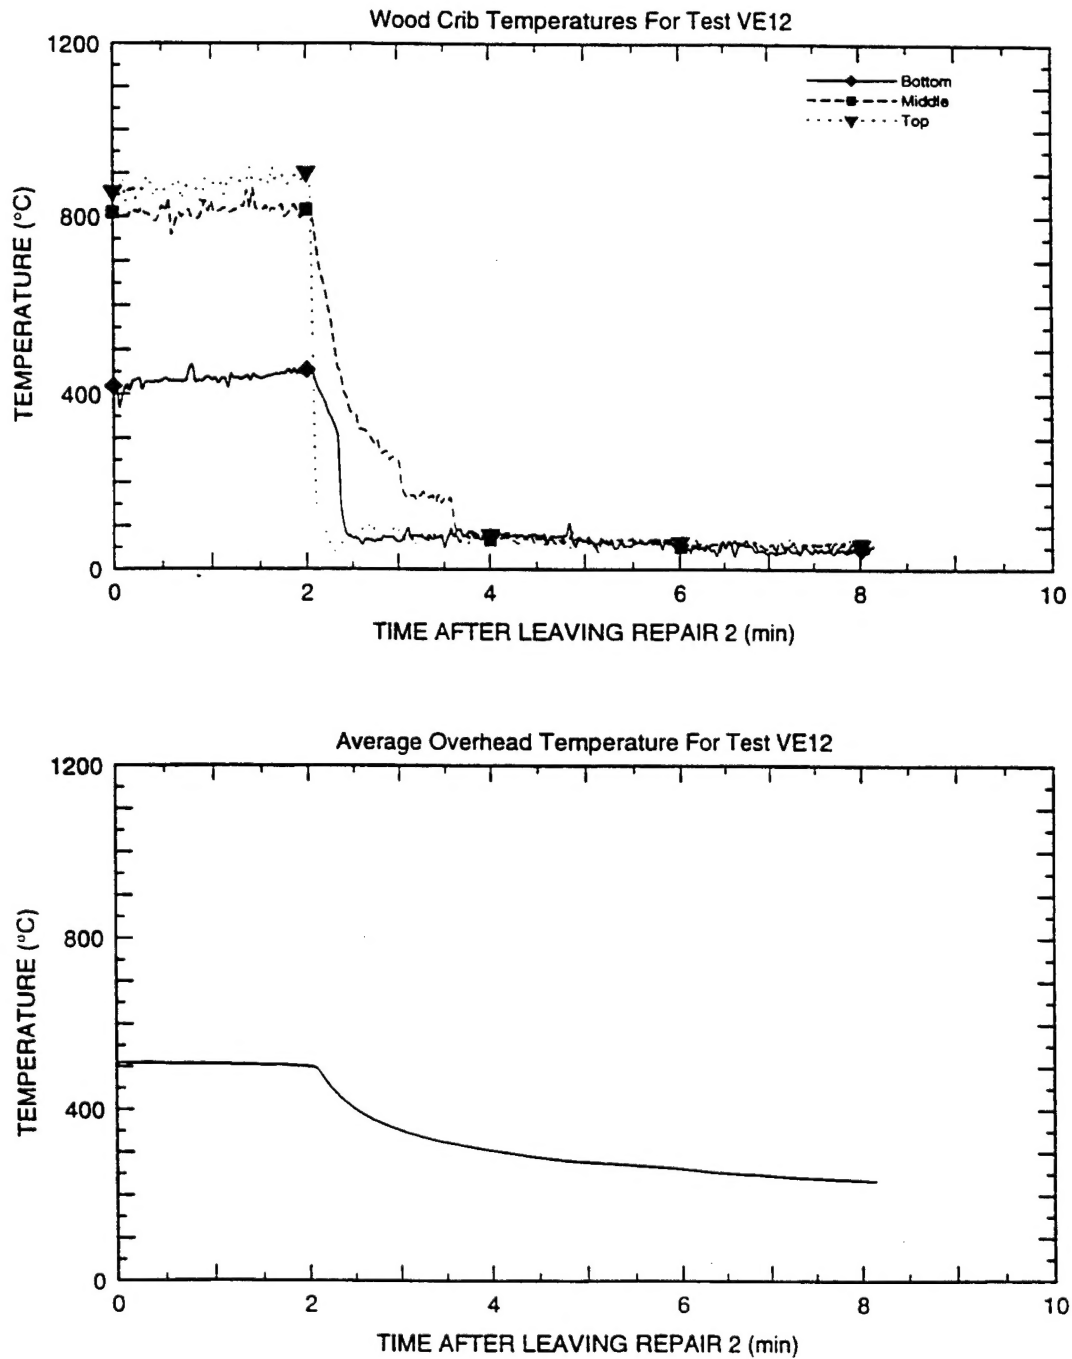
Fig. A23 — Wood crib and average overhead temperatures for test VE012
